REPORT NO. 301-AETL-80-021-971-3882-21

FMVSS 301-75
VEHICLE SAFETY COMPLIANCE
AND
RESEARCH AND DEVELOPMENT TESTING
OF
"FUEL SYSTEM INTEGRITY"

VOLKSWAGENWERK AG
1980 VOLKSWAGEN VANAGON - 3 DOOR STATION WAGON
NHTSA 801301

FINAL REPORT

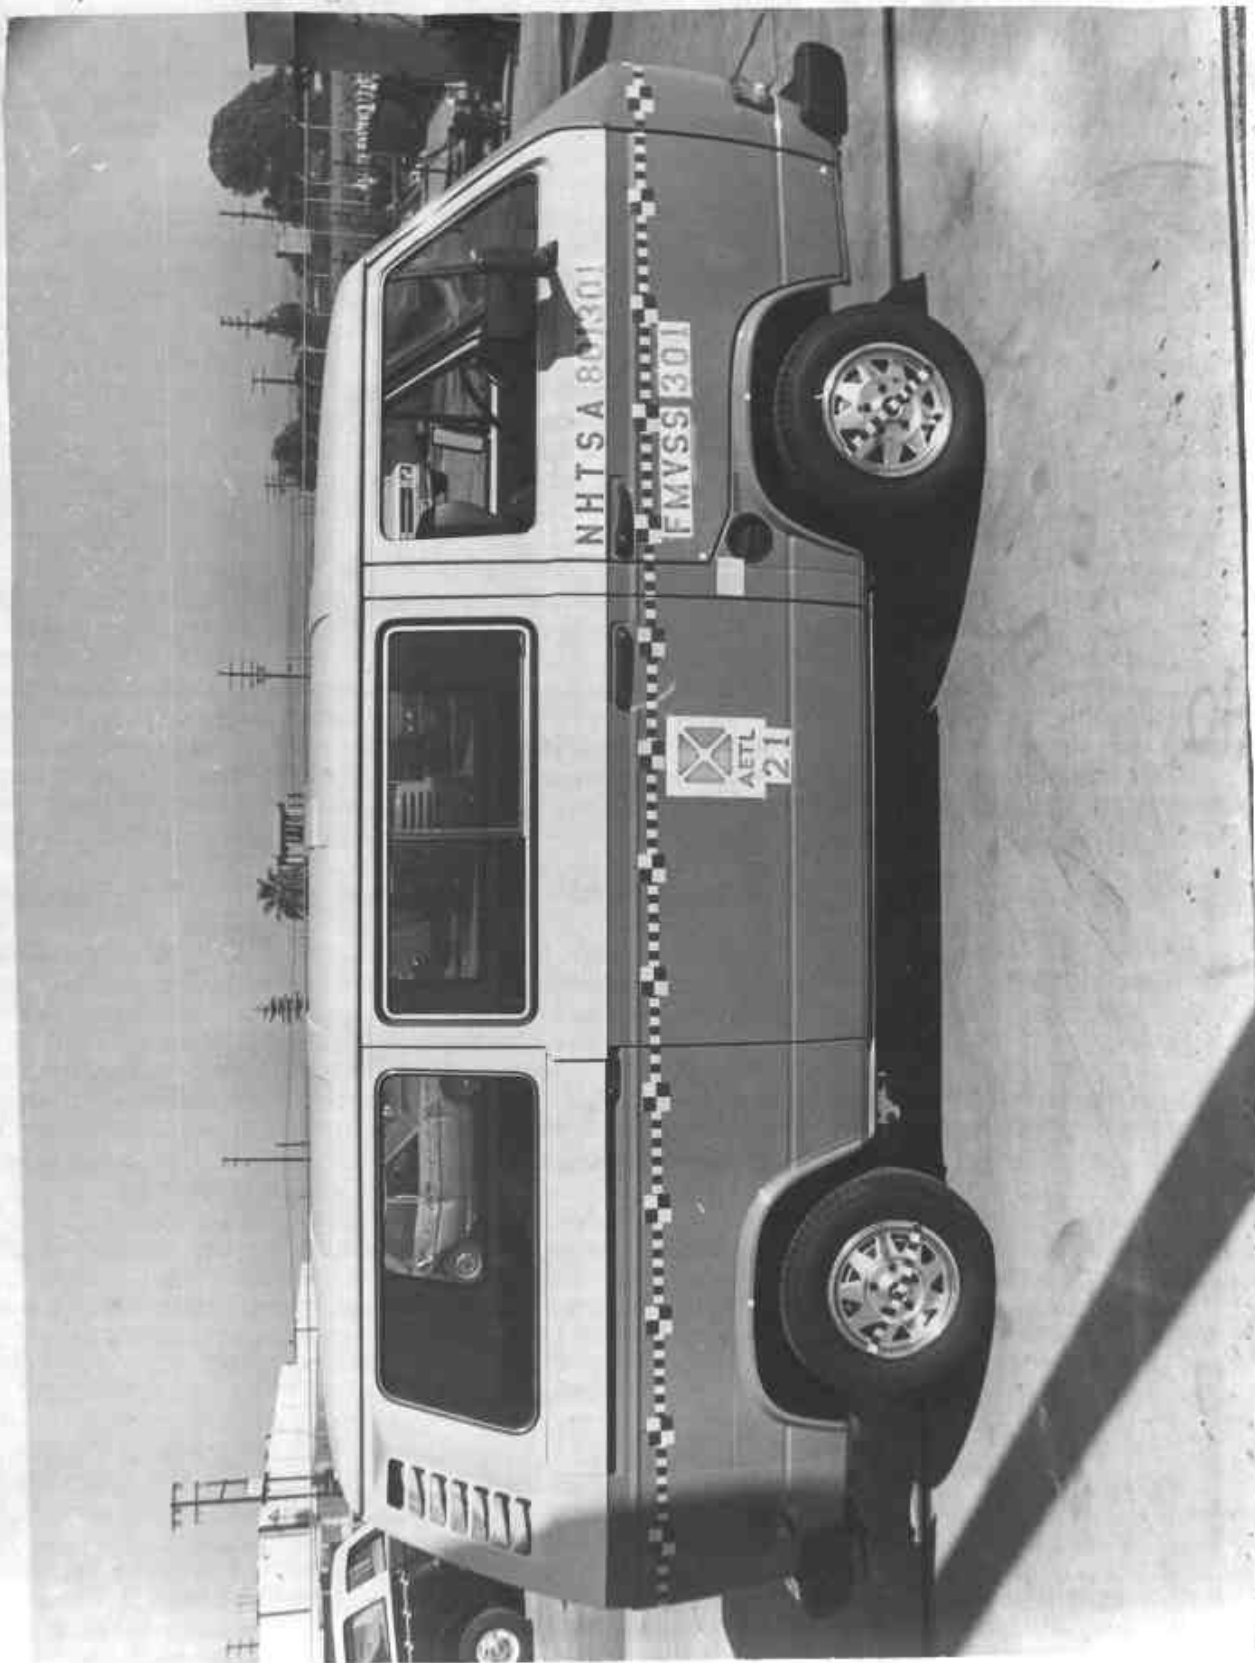
Figure 2-3
1980 Volkswagen Vanagon - 3 Door Station Wagon
NHTSA 801301
Pre-Test, Right Side View

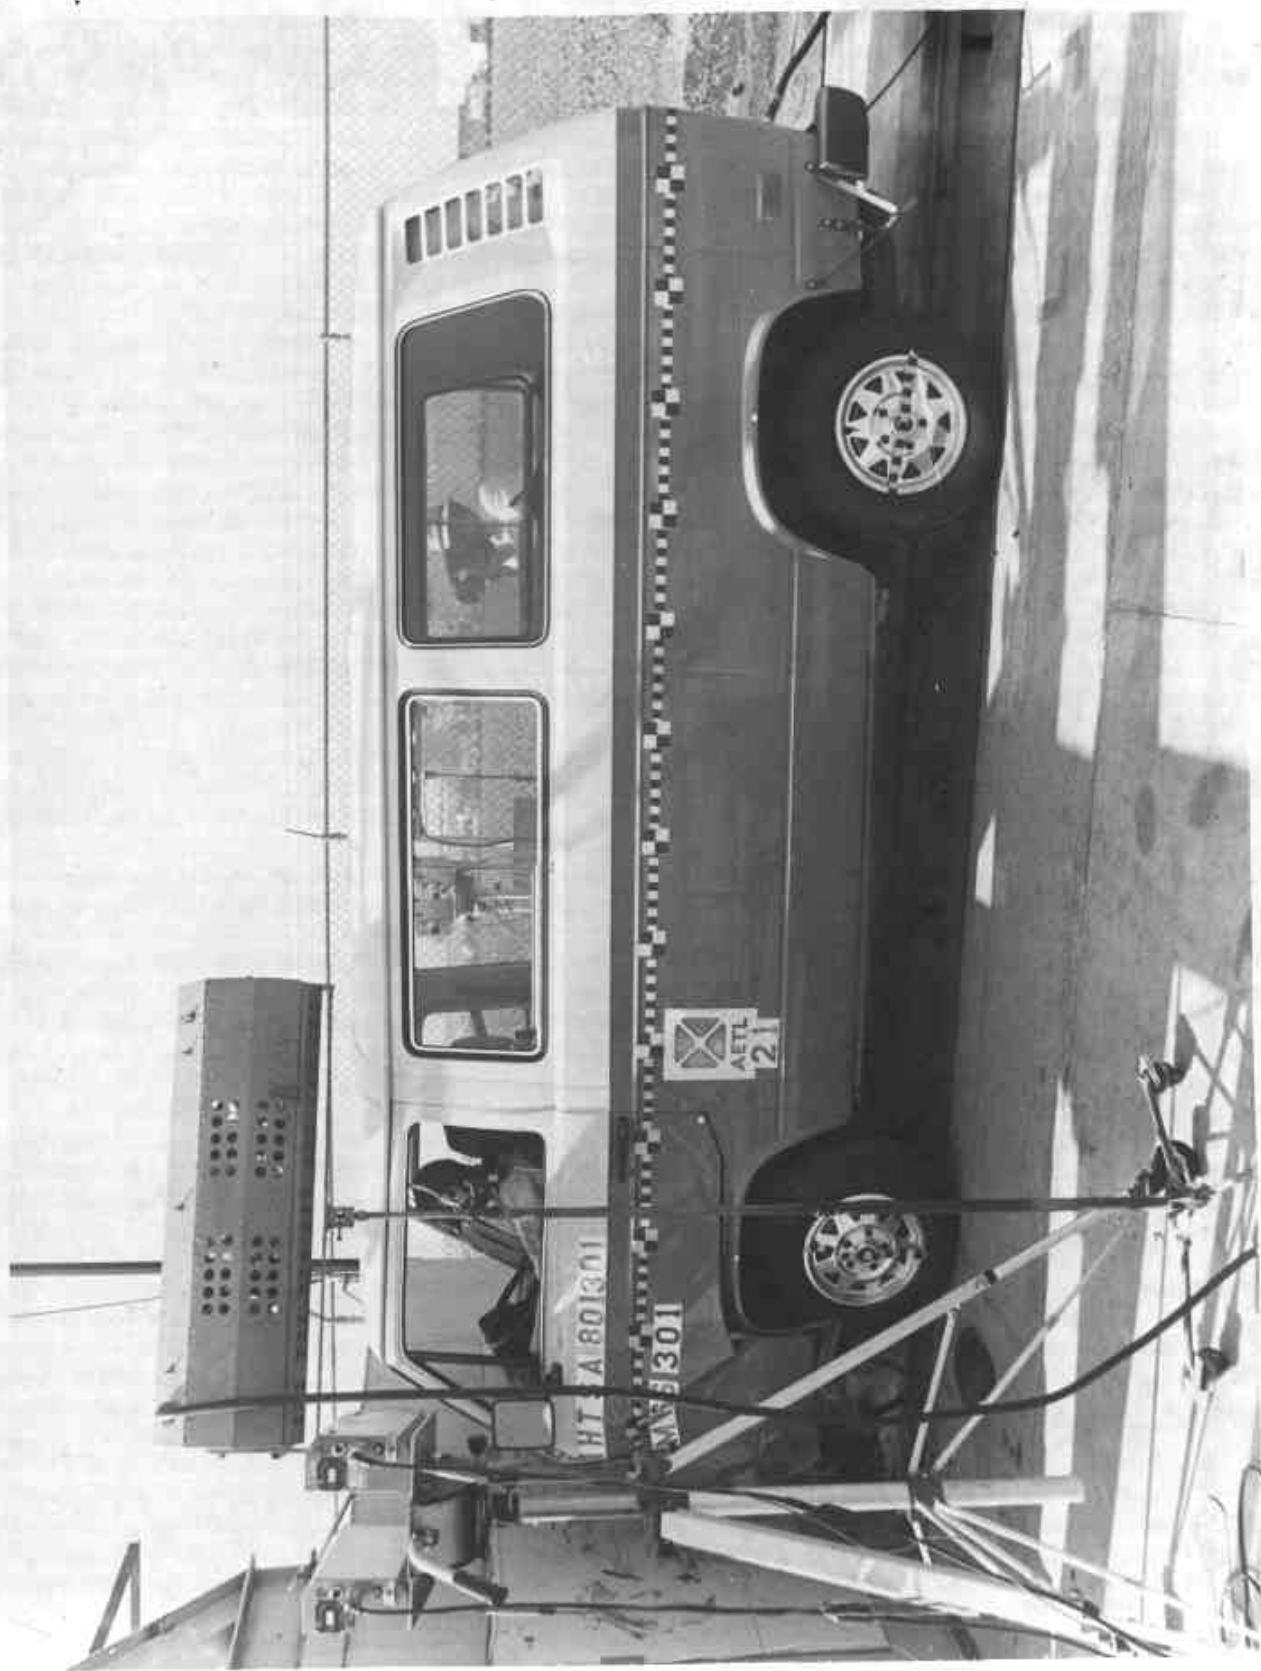
Figure 2-4
1980 Volkswagen Vanagon - 3 Door Station Wagon
NHTSA 801301
Post-Impact, Left Side View

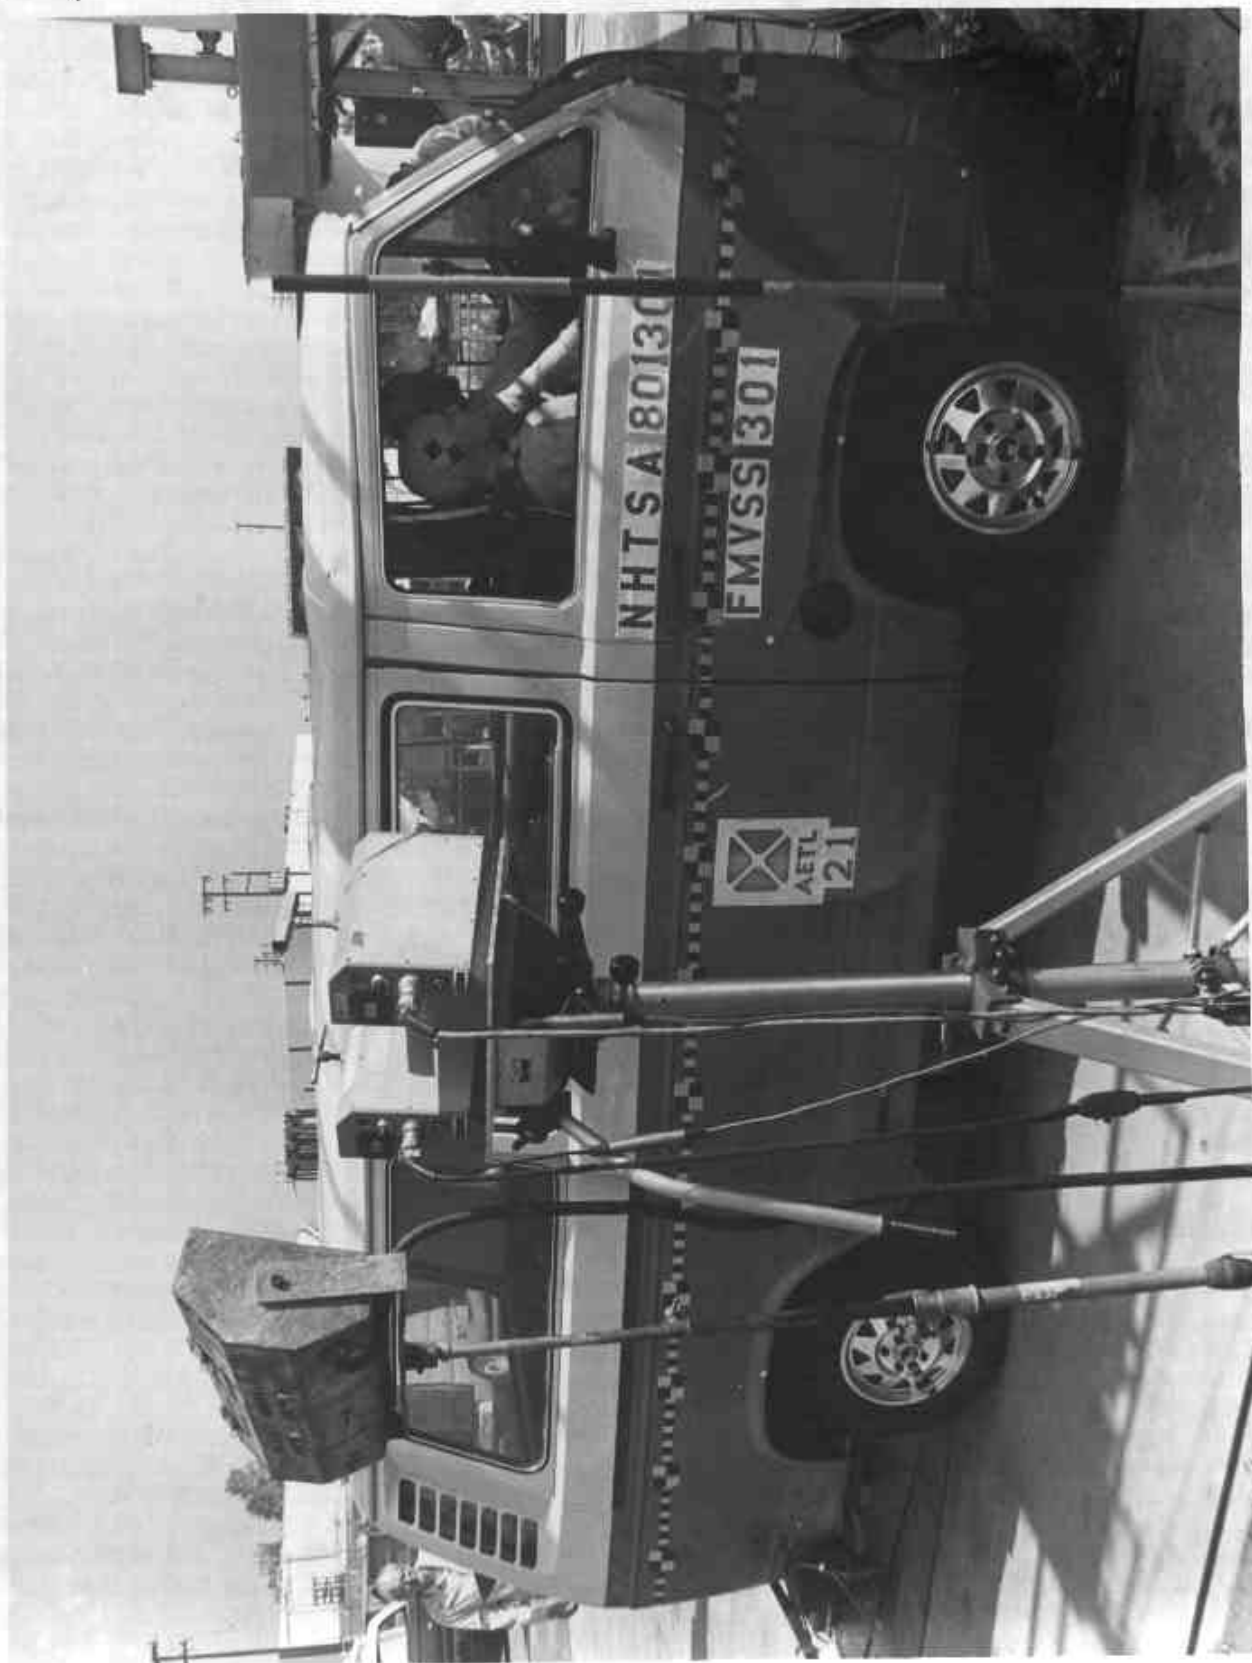
Figure 2-5
1980 Volkswagen Vanagon - 3 Door Station Wagon
NHTSA 801301
Post-Impact, Right Side View

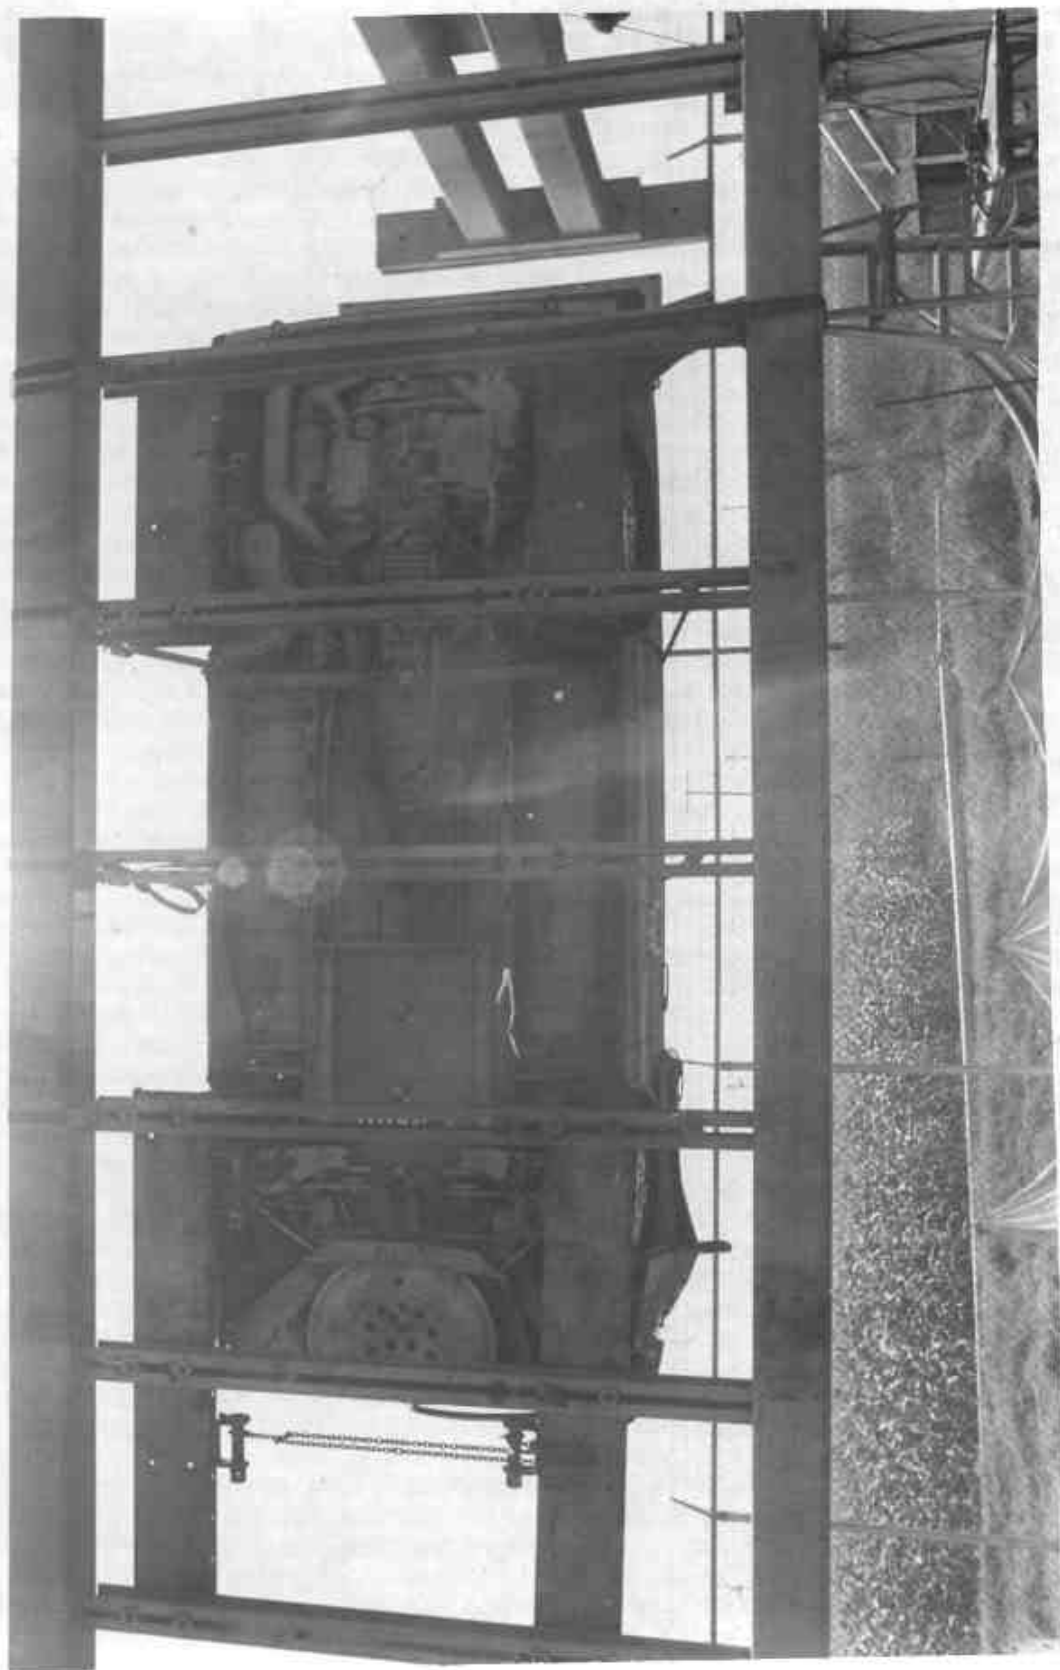
Post-Impact, Rollover Test, 90° Increment

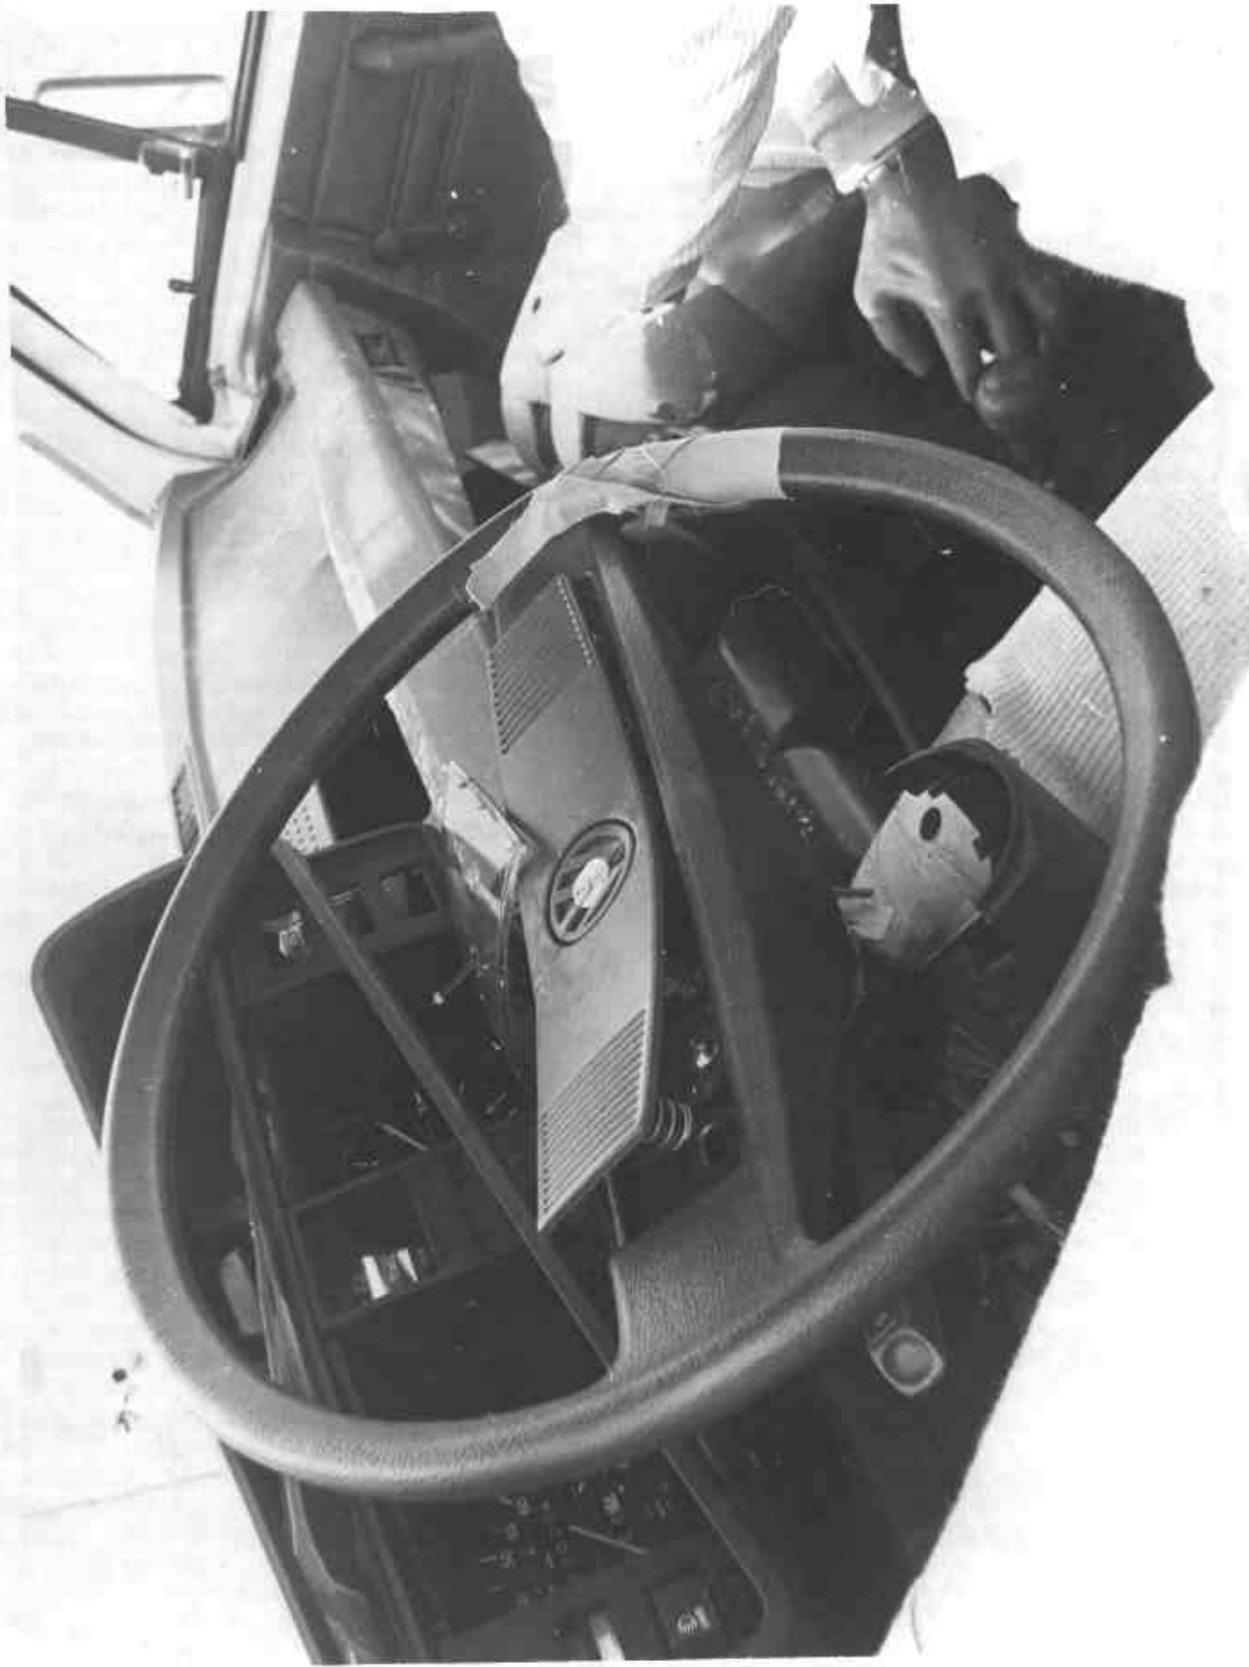
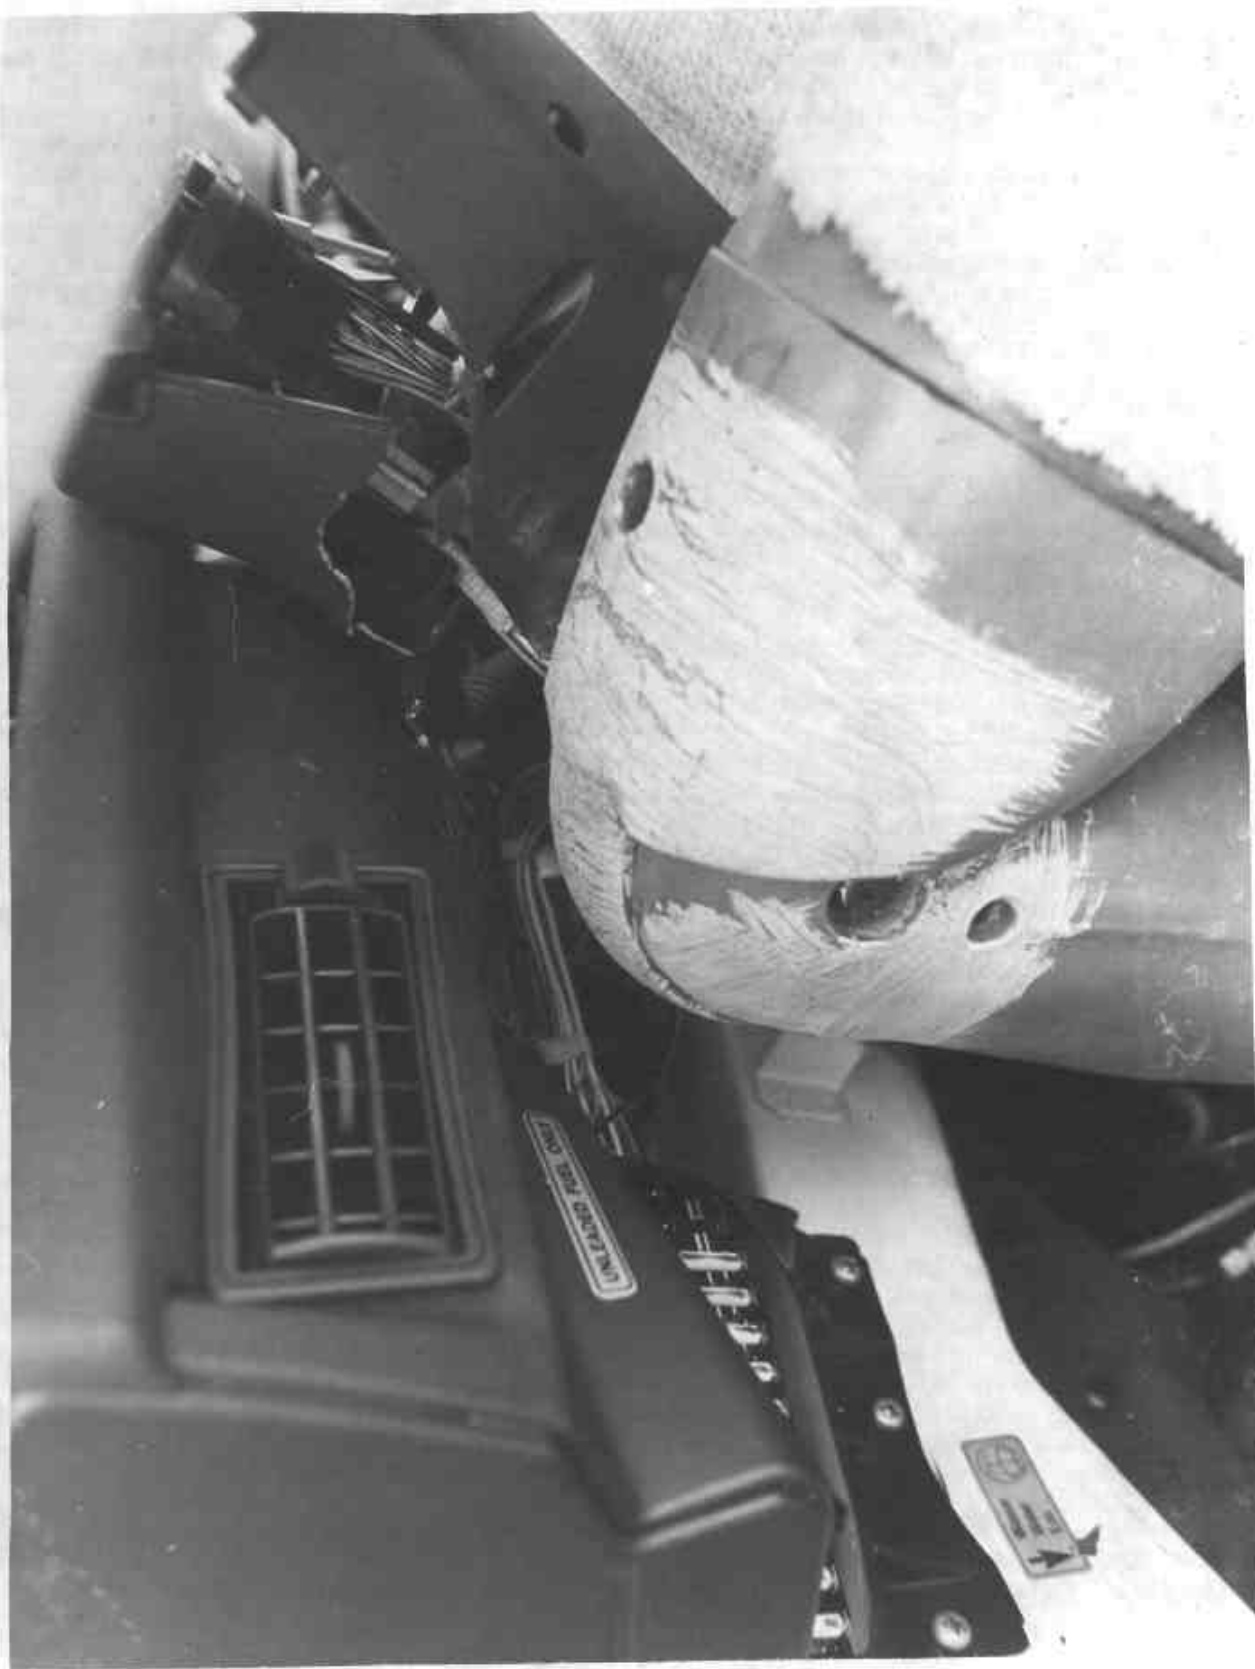
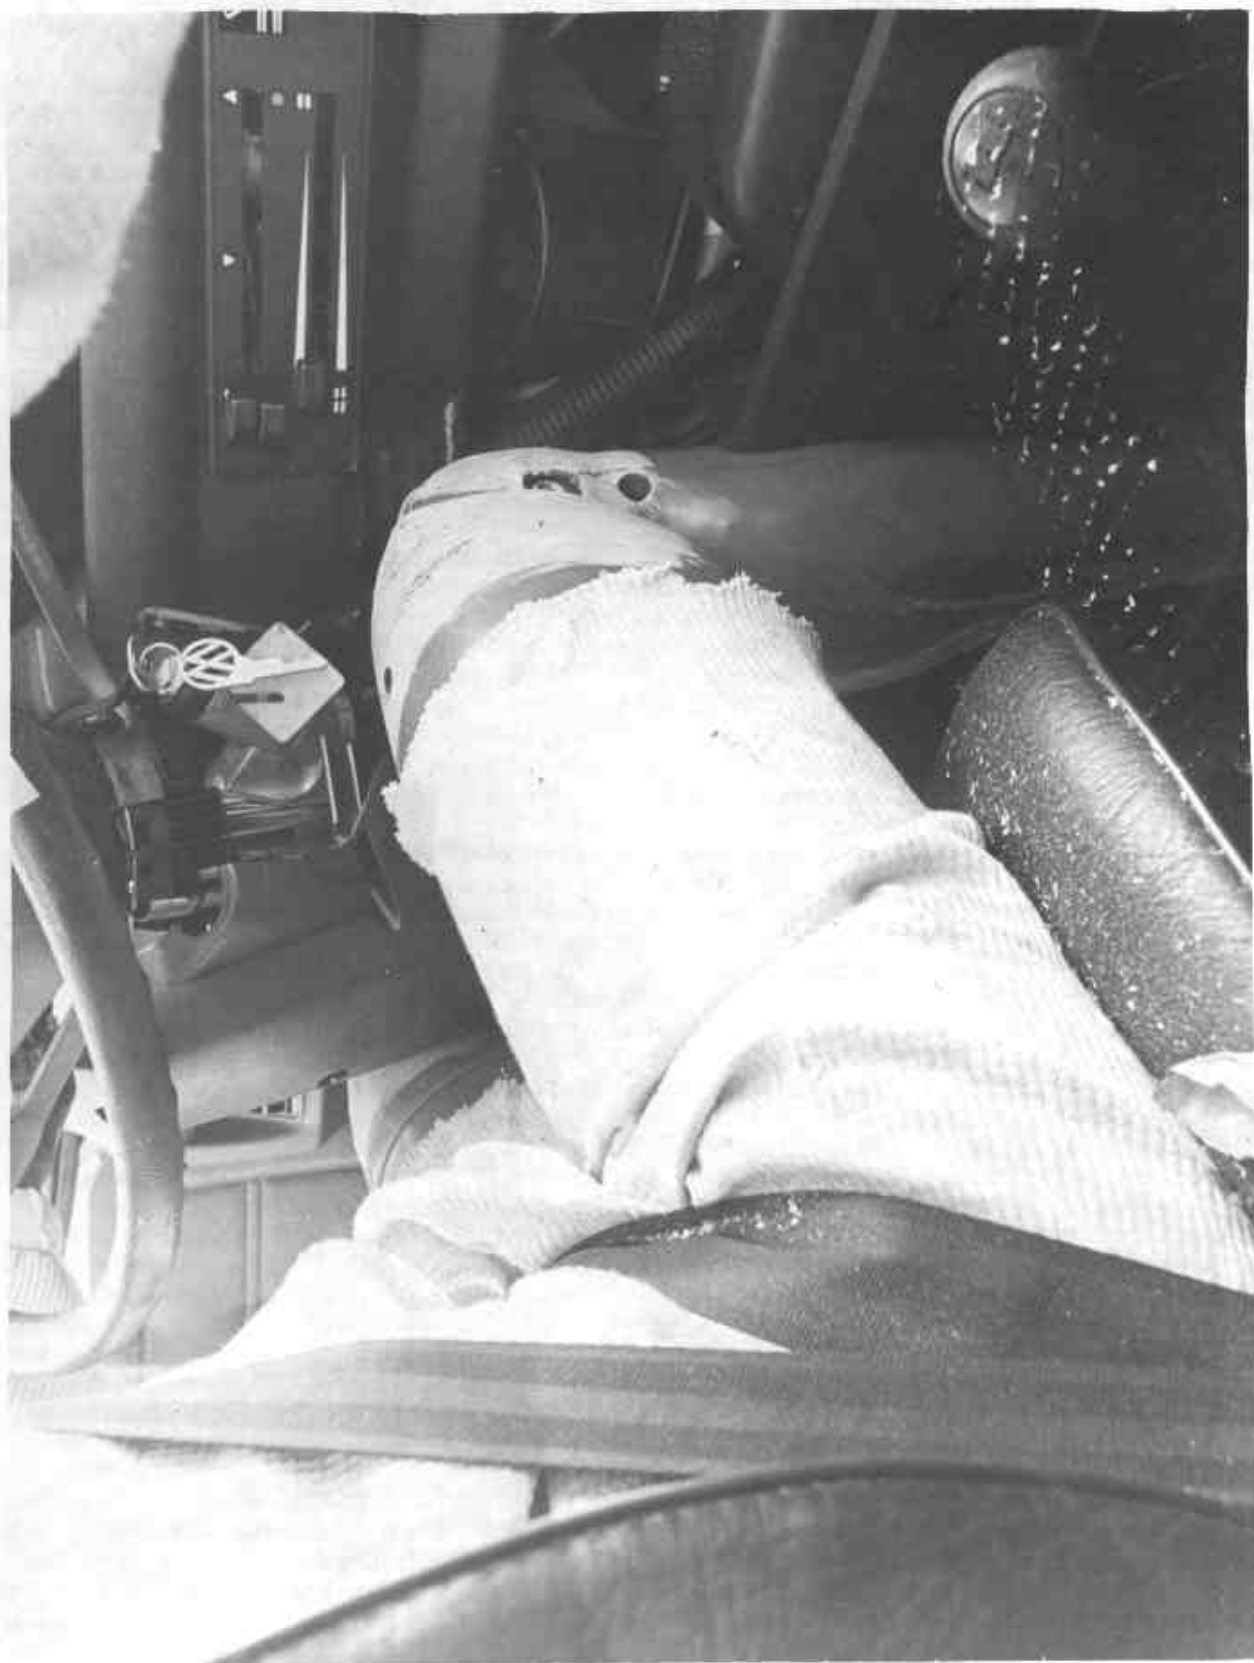
Post-Impact, Driver Dummy Contact Area

Figure A-5
1980 Volkswagen Vanagon - 3 Door Station Wagon
NHTSA 801301
Post-Impact, Driver Dummy Contact Area

Figure A-6
1980 Volkswagen Vanagon - 3 Door Station Wagon
NHTSA 801301
Post-Impact, Driver Dummy Contact Area

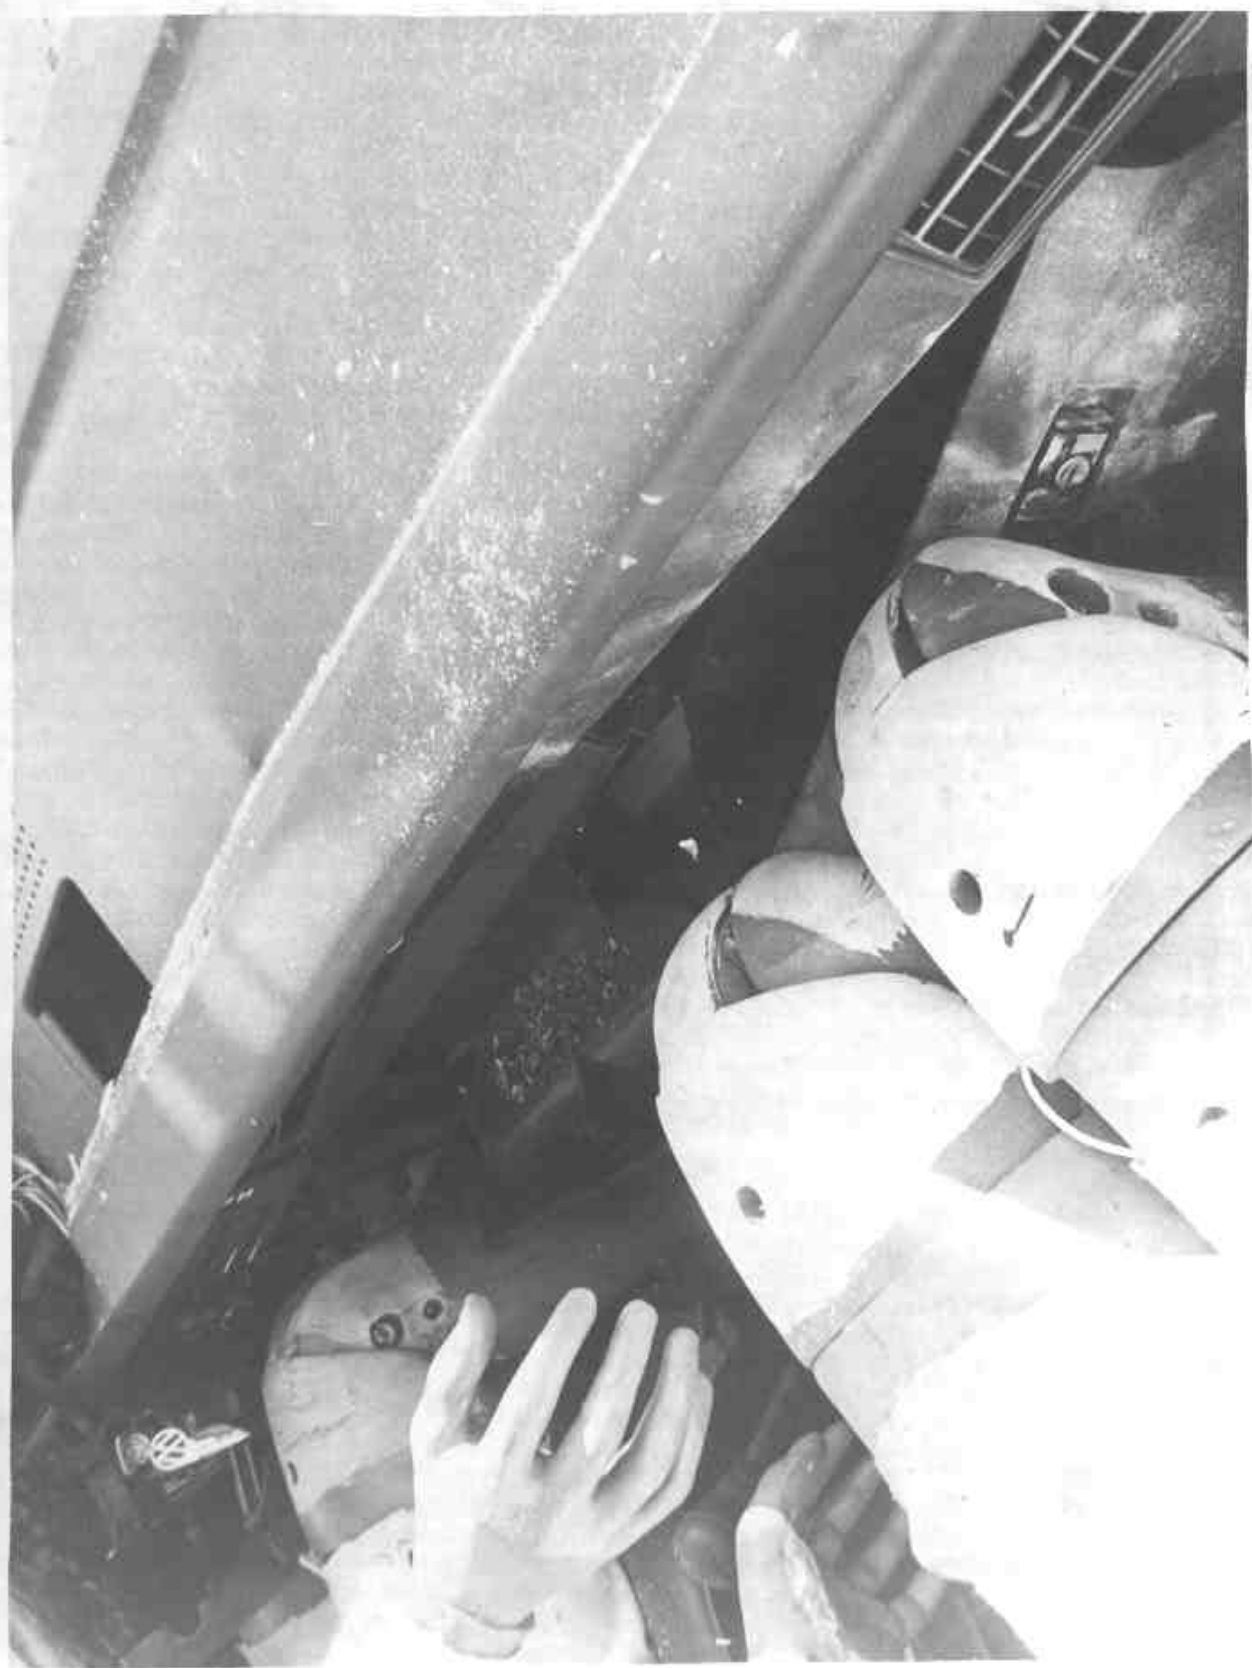
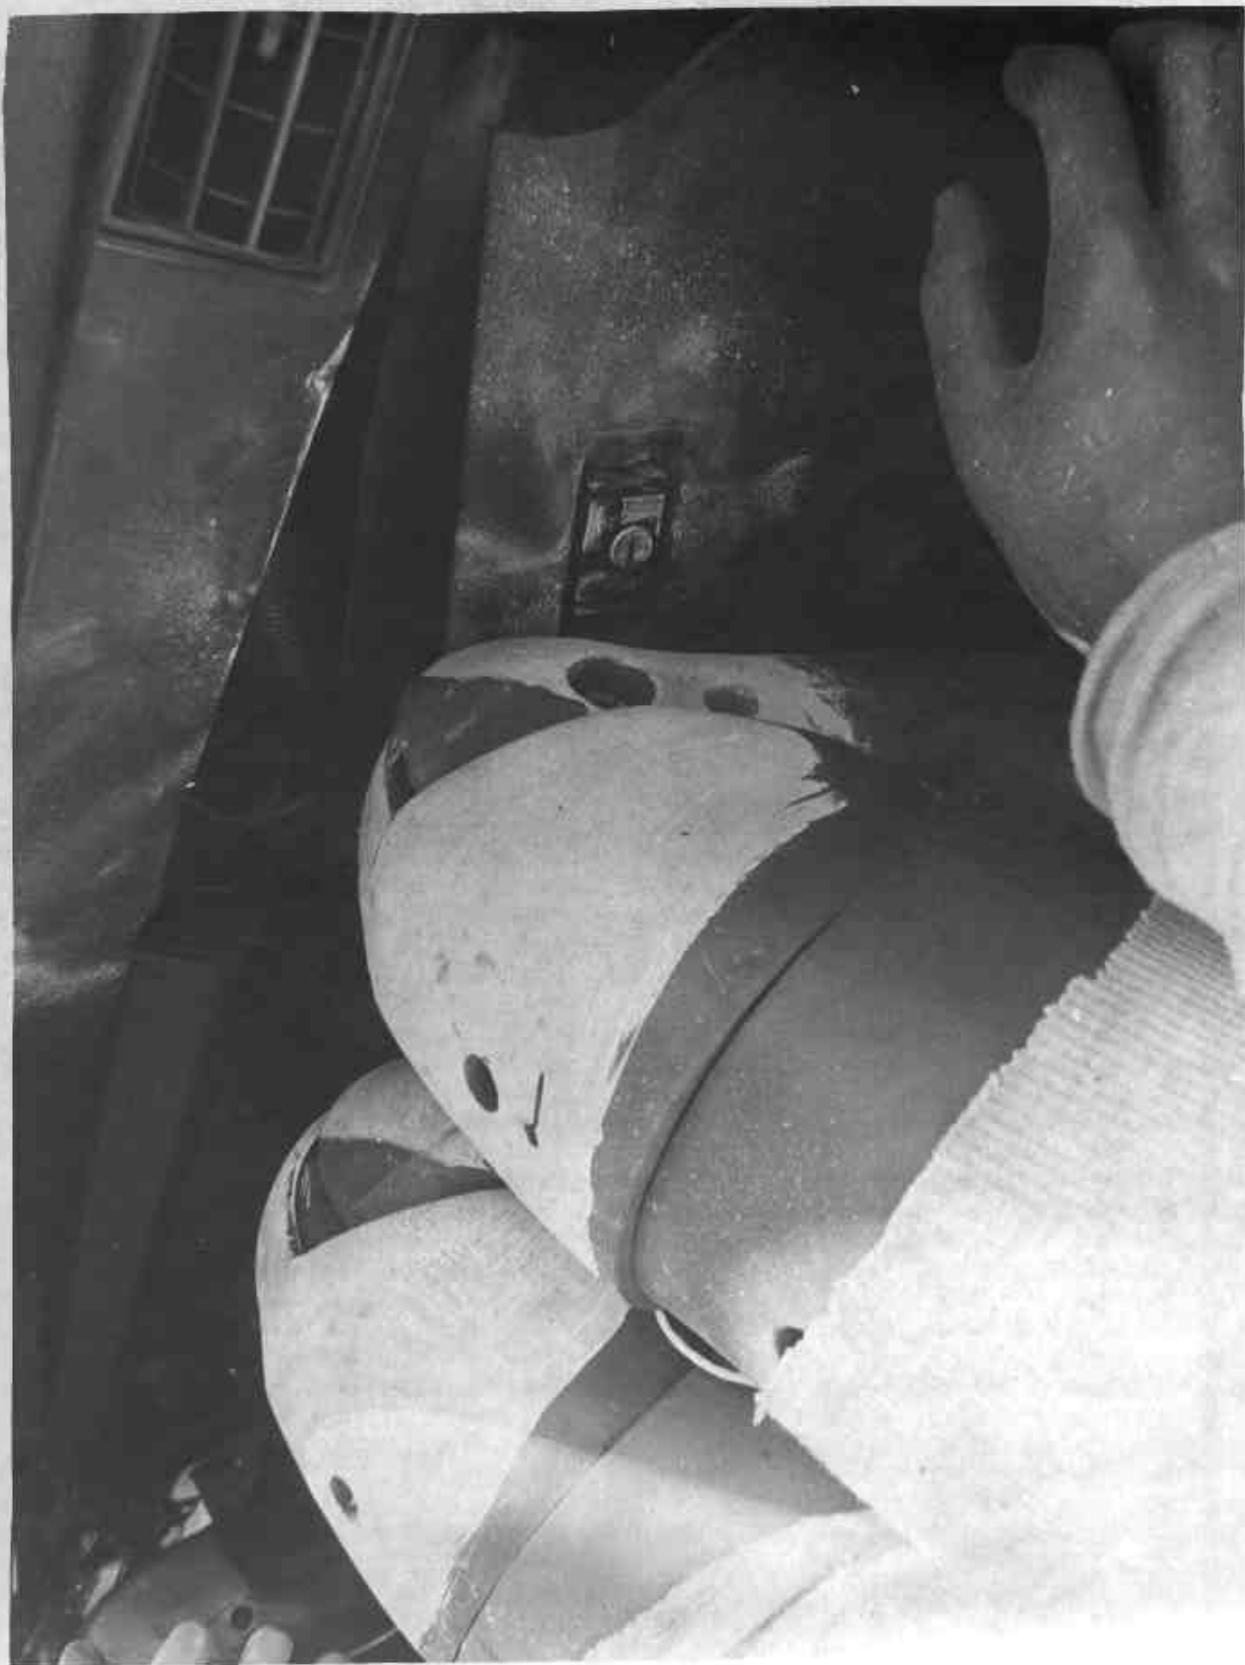
Figure A-8
1980 Volkswagen Vanagon - 3 Door Station Wagon
NHTSA 801301
Post-Impact, Passenger Dummy Contact Area

Post-Impact, Passenger Dummy Contact Area
